PLATING SURFACE CORRUGATION

Pete Apple

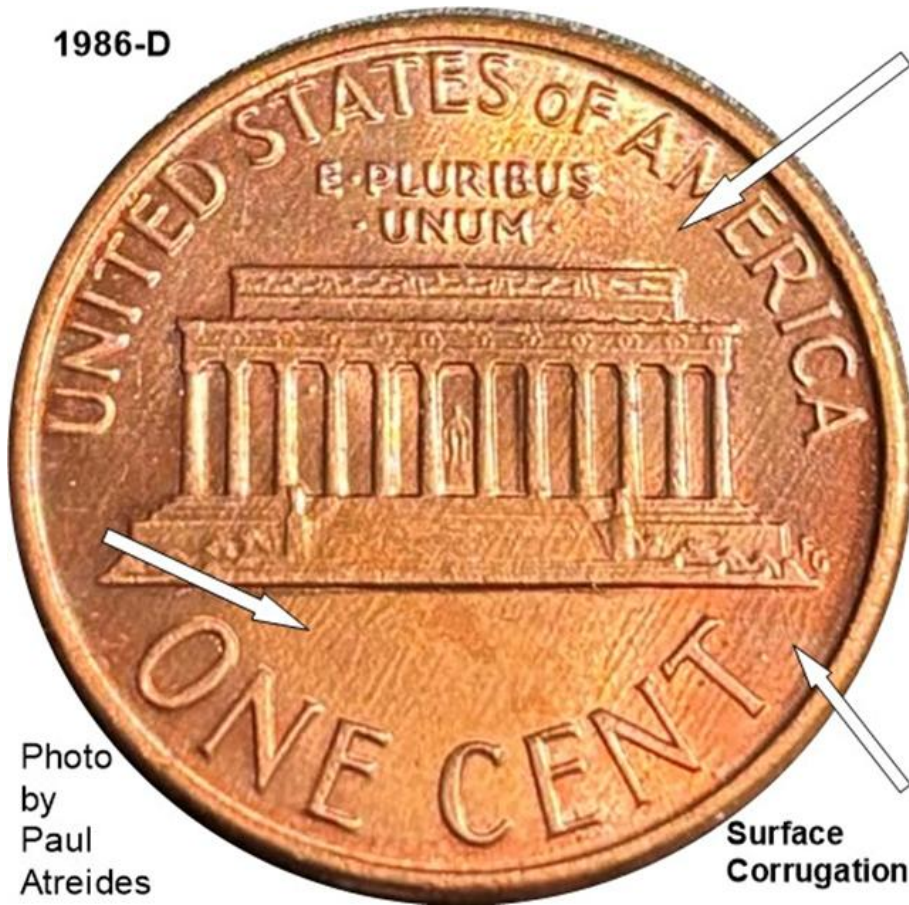
1986-D

I am convinced that plating surface corrugation on copper plated zinc cents, often observed as ridges and valleys, is caused by issues in the plating process. (See photo below).

- Since plating ripples also appear on unstruck planchets, we know that the ripples appear prior to striking.**
- The irregular shape of individual ripples indicates that they are not planchet striations, which are expected to present a more linear morphology.**

I think what is happening to produce the ridges and valleys in the copper plating is that: As the crystalline lattice structure of the plating reorients to release stress, alignment occurs and ripples form in roughly parallel rows. The reduced stress level of the ripples has actually been verified in experiments by measurements.

Surface
Corrugation
