FIRST DOMESTIC CASE OF 'DESIGN CREEP'

COLLECTOR FINDS SMALL PILE OF 2014-P JEFFERSON 5-CENT COIN ERRORS IN ROLLS

BY MIKE DIAMOND / SPECIAL TO COIN WORLD

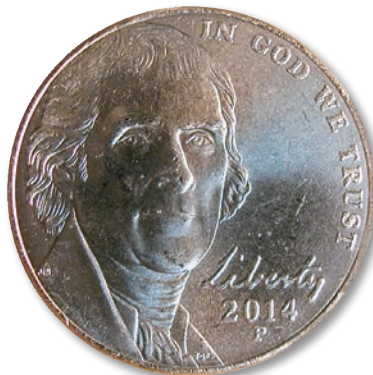
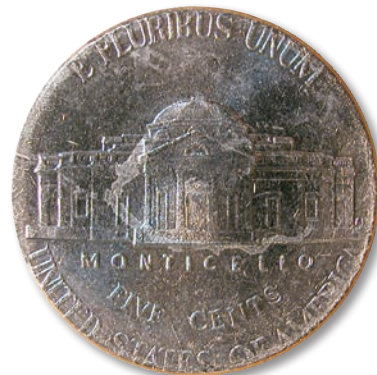
The reverse face of this 2014-P 5-cent coin shows a case of design creep. The reverse (hammer) die face expanded radially, beyond the working face of the collar.

The reverse face lacks the design

rim, because this portion of the die face extended beyond the working face of the collar. All of the peripheral letters on the reverse face are cut off where they meet the coin's edge. Truncation is more severe along the southern arc of the coin's perimeter, possibly due to a slight asymmetry in the degree of radial expansion. This is not unexpected, as many soft die errors show asymmetrical and localized development. In fact it's conceivable that a future case of design creep might involve only a portion of the die's circumference.

Since the flared hammer die face was wider than the collar, one might anticipate the die pressing down upon the collar, generating a thin partial collar flange along the upper portion of the edge. However, no partial collar is seen on any of the 2014-P 5-cent coins. This is not particularly surprising, given that horizontal misalignments of the hammer die don't consistently generate a partial collar. In a horizontal misalignment, part of the hammer die overlaps the top of the collar, potentially depressing it (many collars rest on springs or air pistons). Another possible reason why the collar wasn't depressed during the production of the design creep errors is that

The reverse face is highly reflective and has a peculiar cottage cheese texture that is best developed in the center of the coin. Here the details of Monticello are indistinct. The odd surface texture is simply another indication that the die was experiencing abnormal plastic deformation.

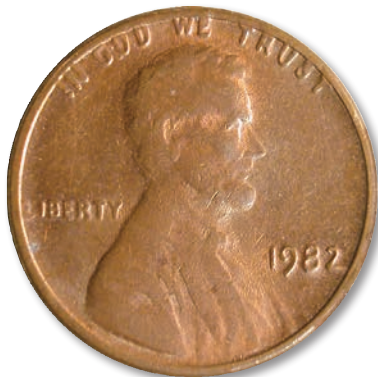
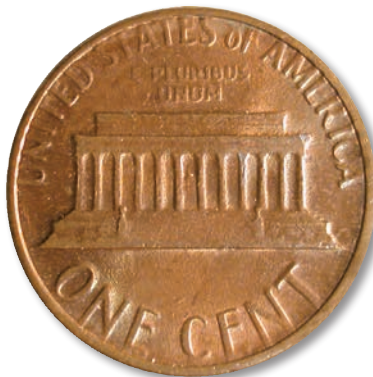
This 1982 Lincoln cent shows a case of peripheral die expansion and erosion. Peripheral letters are truncated where they meet the design rim.

In the Aug. 13, 2012, column I introduced a die deformation error to which I attached the name "peripheral die expansion and erosion." Known only among 1982 Lincoln copper-alloy cents, the several affected die pairs show radial expansion of the peripheral field, but not the surrounding rim gutter. As the field portion of the die expands, it is simultaneously worn away, leaving peripheral letters truncated. An example is shown here.
