WHY DOES PLATING CRACK and SPLIT?

A tentative theory explaining the cause of circumferential plating cracks and split plating.

Pete Apple

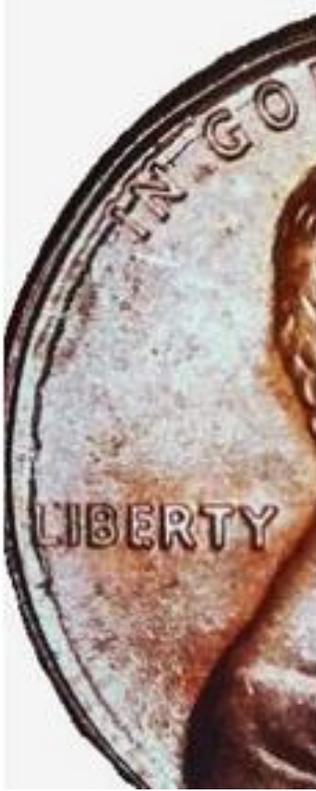
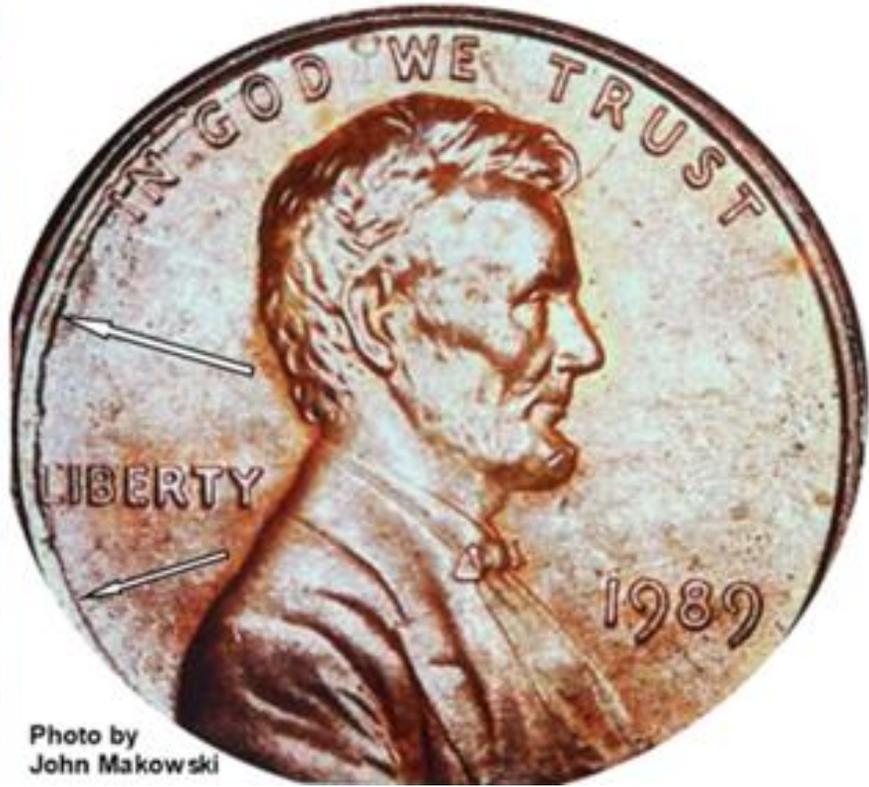
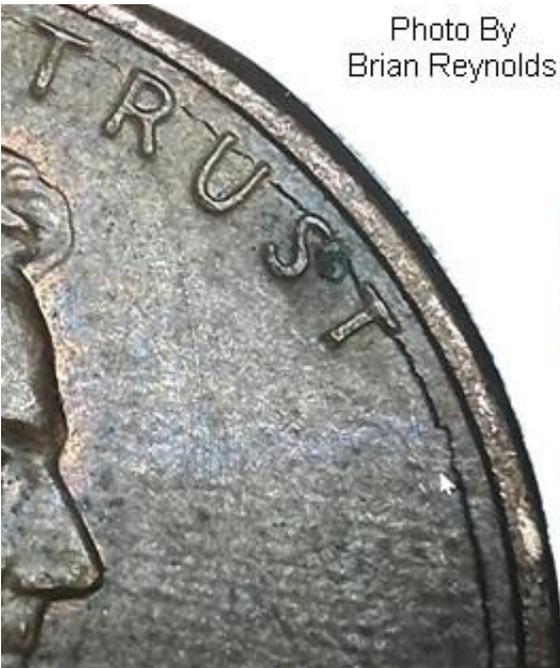
Photo by John Makowski

According to Error-Ref, plating that peels up or cracks before or after the strike is comparatively rare.¹ I have certainly found that to be the case as I have researched the subject, finding a paucity of examples. (Two examples of a Circumferential Plating Crack follow).

My tentative theory is that these features appear, as the result of stress in the copper plating, along the Yield Point (that area where

elastic deformation of the copper plating becomes plastic deformation).

Yield Point: When the stress reaches the yield point, the material transitions from elastic to plastic deformation. This point marks the limit of elastic behavior and the start of permanent deformation. Since these examples of circumferential plating cracks are approximately 1 mm from the design rim, I think the implication is that a distance from the rim of approximately 1 mm defines the area of the Yield Point for our purposes.

Copper plating on a Lincoln Cent develops a CRACK primarily because an issue with the plating process causes irregular inherent plating stress. For a Circumferential Plating Crack, a suboptimal radius of the junction between the die face and rim gutter provides a “road map” for the crack location.

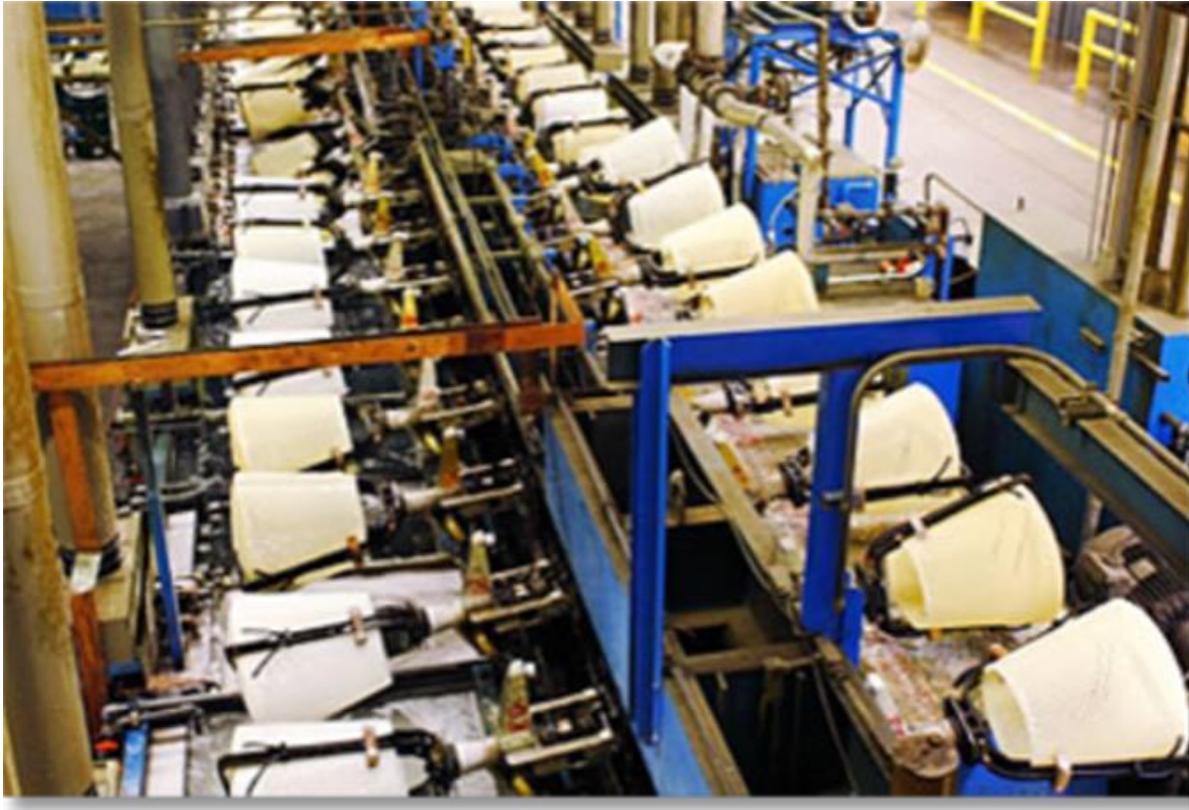
Barrel Plating Line, Jarden Zinc

The electroplating of a cent is with $8\mu^3$ thickness of copper. Planchets used by the US Mint for the cent are obtained from Jarden Zinc where they use a barrel plating process (see photo below). (Jarden Zinc is now rebranded as ARTAZN LLC.) Plating is applied after the blanks pass through the upsetting mill.⁴

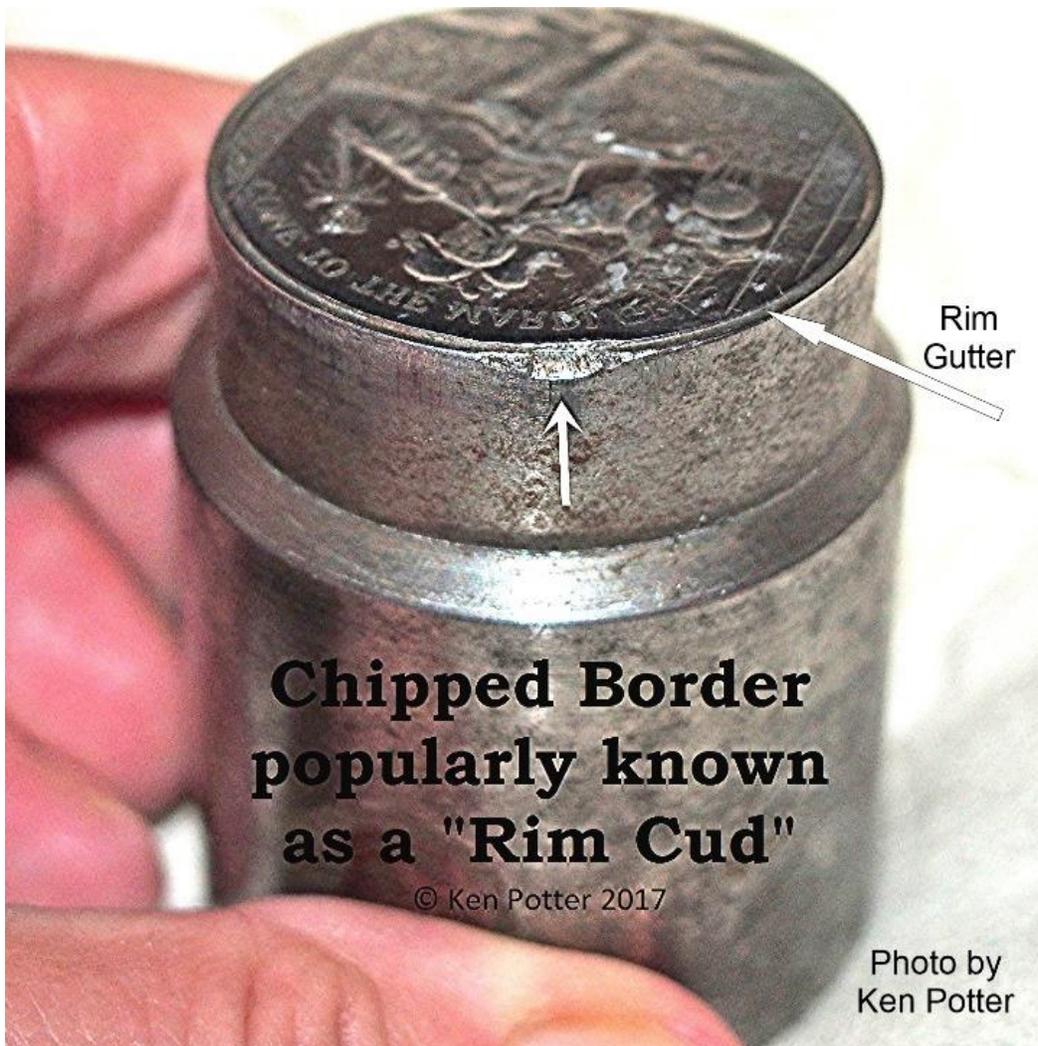
The radius of the design at the rim/field junction is formed at the boundary between the Die Face and the Rim Gutter. (A Rim Gutter is shown on the image of a die in the image below). A sharp edge at that

boundary will produce a radius that is too low, and an excessively rounded edge will produce a radius that is too large.

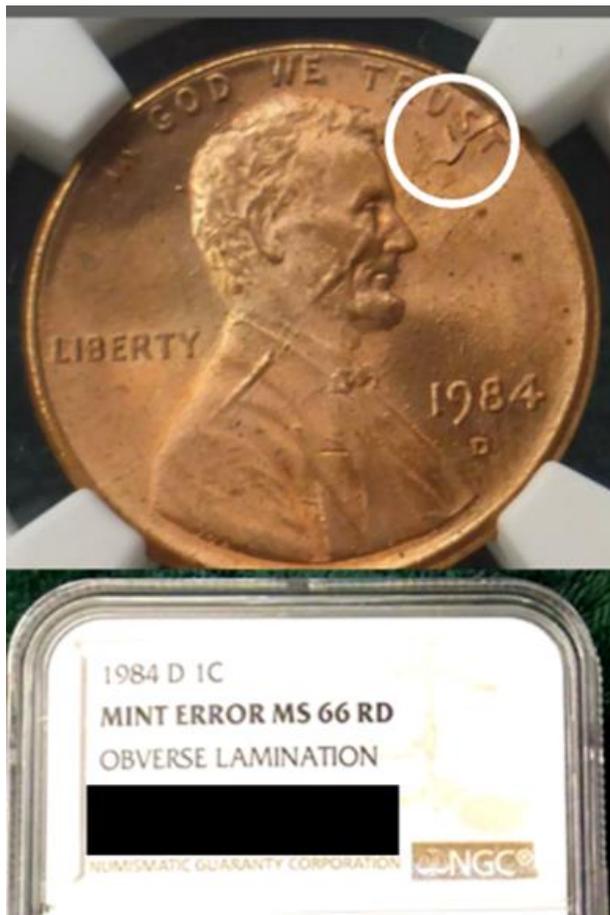
I suspect that the different definitions of lamination (delamination) are a major contributing factor to some TPGs attributing a plating peel on a zinc cent as a lamination. This is one such example. Here it is quite clear that a linear plating blister has broken open at its upper end, resulting in a plating peel and not a lamination as would be numismatically defined.

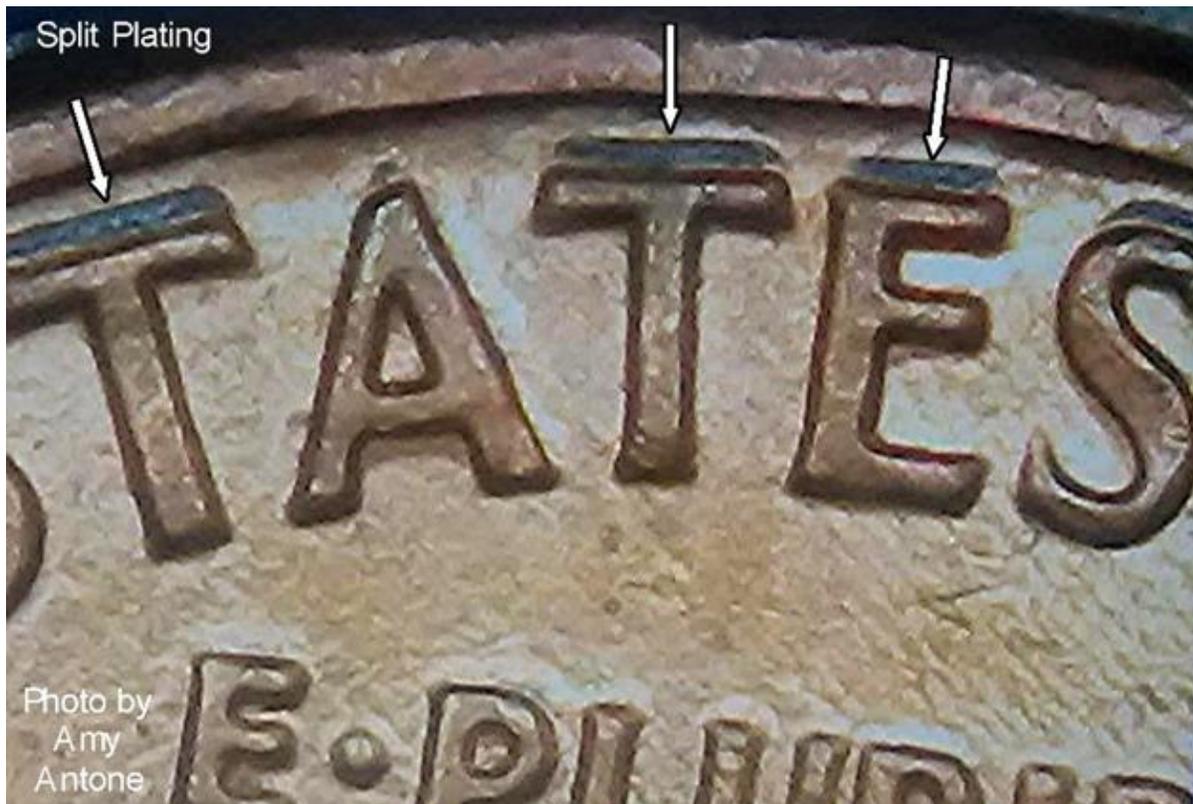
SPLIT PLATING

Whereas plating cracks are most likely initiated by plating irregularities, split plating may be more of an expression of the geometry of the various die devices.

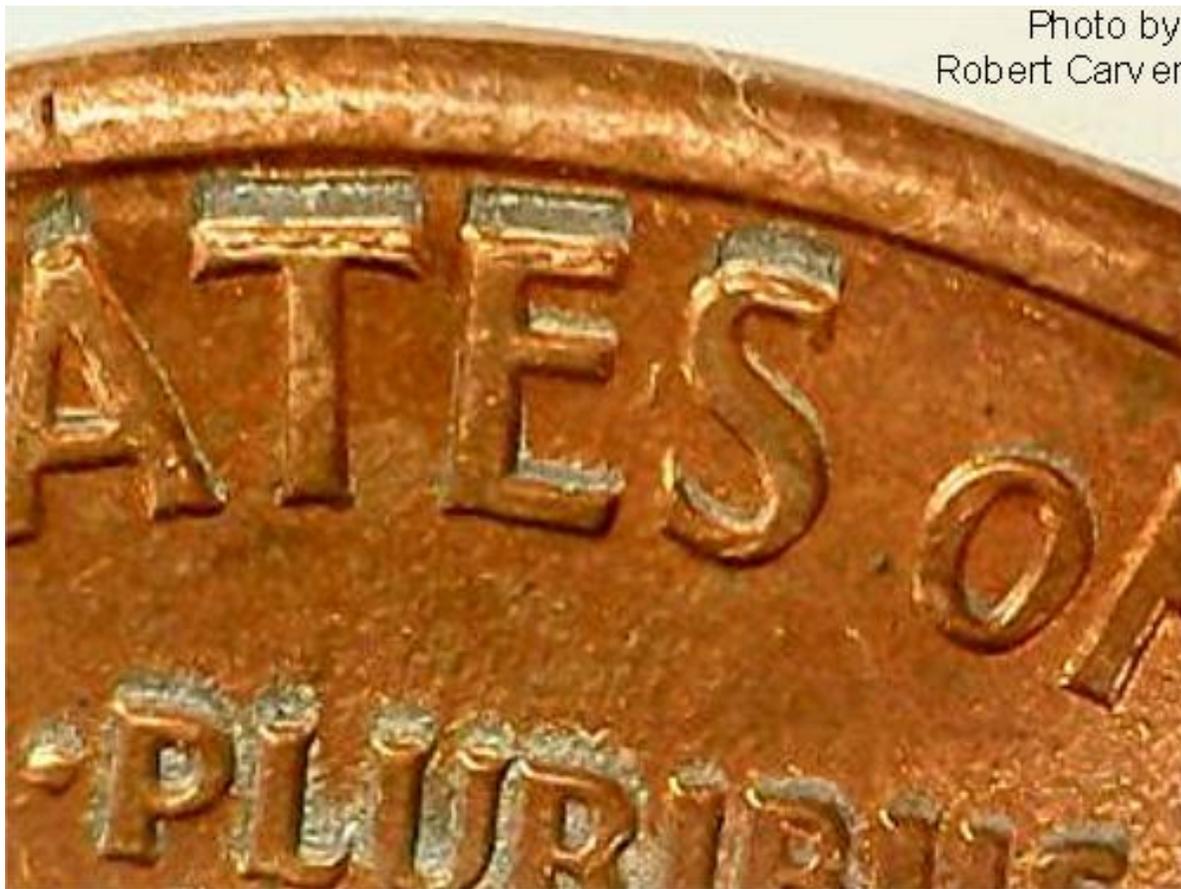
This coin shows flow lines embedded in the split areas.

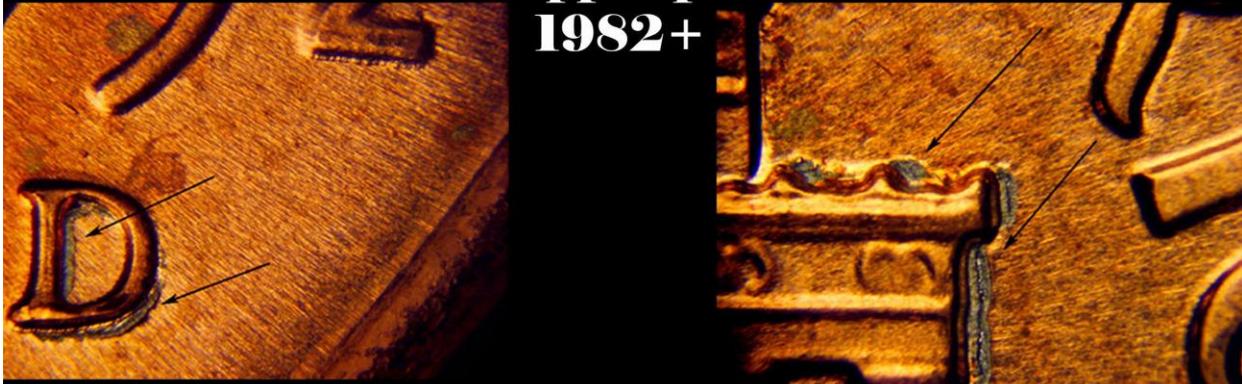
Split Plate Doubling

I think that the suboptimal radius of a device is the primary determinant for the appearance of split plating. In the first part of the paper, I quoted: “Copper is highly anisotropic (having a physical property that has a different value when measured in different directions). We know that the stress state close to a geometrical variation, such as a sharp corner, is inherently multiaxial.”¹¹ I think that these characteristics are responsible for the elastic zone along the rim being further away (approximately 1 mm) from the rim as compared to the elastic zone for a single letter. Notice that the point of initiation of the copper disturbance is typically further away from the rim than it is from a single letter. In other words, a longer uninterrupted linear edge to a device seems to have the effect of extending the elastic zone and yield point further away from the device. Notice the splitting along the edge of the Memorial in the following photo is further away from the edge than that on the mint mark.

These examples of split plating arise primarily from a suboptimal corner where the radius is too low (the corner is closer to a right angle).

The plating SPLITS primarily because of the stress from a suboptimal radius of the junction between a device and the die face.

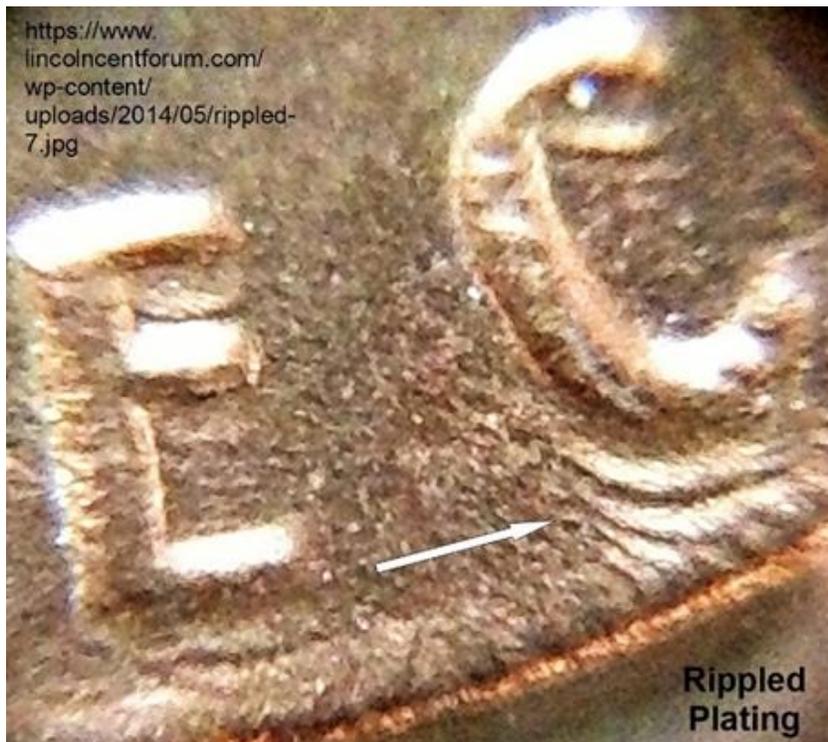
When the radius is too high, wrinkling (rippling) of the plating will result (see photo).

Metallurgically, a corner⁷ (where the field meets a device) needs to have optimized radius. If the radius is too large, wrinkling (rippling) of the plating will result (see photo page 17). If the radius is too low (closer to a right angle), it produces a source of stress which causes the plating to split. (See diagram below for definitions). Cracks are more likely to initiate and propagate at corner locations.⁸
